Manhole Inspection Summary

Manhole # S45C2_020MH

Insp Date: **12/19/07 9:17 AM**

Location Address: **1324 Pontiac Ave**

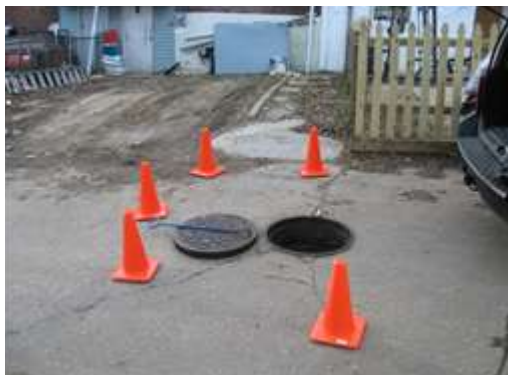
Location View

Cambria-Pontiac

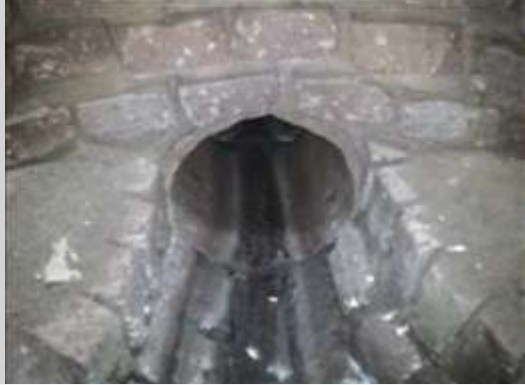
12 O'Clock Outflow

8 in. Circular Gravity Sewer
Pipe Out @ 12 O'Clock

Pipe Height: **8.4** (in.) Rod and Bar (Angled)
Pipe Material: **Clay** ☐ Pipe Lined
Invert Depth: **10.93** (ft.) Flow Characteristics: **Slow**
Deposits: ☒ None ☐ Mud ☐ Sludge ☐ Debris ☐ Grease
Silt Depth: (in.) Deposits Extent:
Infiltration: **None** Pipe Seal Cond: **Sound**

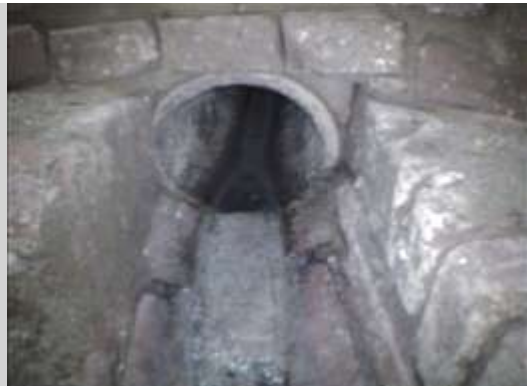
9 O'Clock Inflow

6 in. Circular Service Sewer

Pipe In @ 9 O'Clock

Pipe Height: **8.4** (in.) Rod and Bar (Angled)

Infiltration: **None** Pipe Seal Cond: **Sound**
